## Lesson Learned

### Control Blow-By From Pyrotechnic Devices

**JPL LLC File Name:** 2006-04 (1725) *Control Blow-By From Pyros.doc*

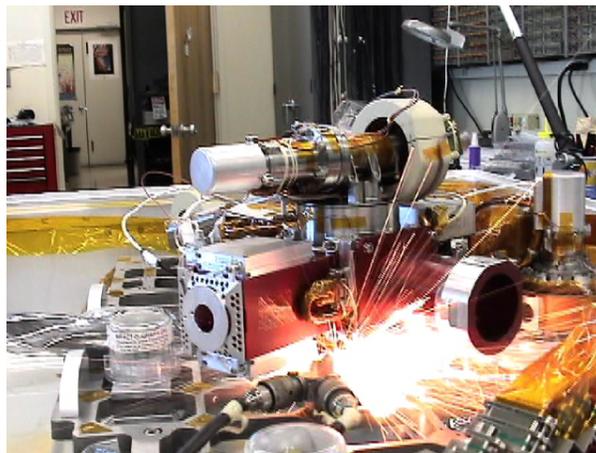
During pyrotechnic shock (pyroshock) and deployment testing of the IDD, a bright flash was observed, accompanied by a loud report (Reference (1)). Examination of a high speed video recording of the test (Figure 1) revealed flame and sparks discharged from the target aperture end of the cutter assembly. This is indicative of excessive leakage or “blow-by” of combustion products past the seals within the pyrotechnic device (pyro). Some blow-by had been noted earlier during testing of similar cable cutters used to release the MER solar array and airbags. Following the IDD incident, all MER test and flight cable cutters were reworked to incorporate a JPL change to the pyro design that significantly reduced the leakage.

Figure 1. Blow-by from IDD cable cutter during 8/9/02 pyroshock test

Some blow-by (due to design tolerances) is typically considered inherent for pyrotechnic devices, the leakage is difficult to characterize or to measure, and it may be exacerbated by workmanship errors in their manufacture. Leakage is more pronounced at low temperature (Reference (2)). Post-incident examination and testing revealed no damage to the flight hardware, including the Rock Abrasion Tool (RAT) instrument that had been installed on the IDD for the test, and no evidence of contamination on any of the adjacent surfaces. There was no hazard to personnel because the testing was done remotely. However, had the optical flight instruments been attached to the IDD during the pyroshock test, significant contamination might have occurred.

1. Always consider pyro venting a possibility and protect sensitive areas of the flight hardware against contamination.
2. The possible venting of particles that could harm critical hardware should always be a concern; consider appropriate protective measures such as moving adjacent hardware and providing barriers.
3. Pyrotechnic testing should always be done remotely so that there is never potential for personnel injury. (See Reference (2).)
4. The placement and orientation of pyro devices on flight hardware should always be done in conjunction with a venting analysis to assure that critical hardware will not be affected during initiation modes.
